Stormwater Maintenance Assessment and Recommendations

Under the supervision of: Professor Annette Spivy ENSP400 Capstone Spring 2020 University of Maryland, College Park

Maryland-National Capital Park and Planning Commission John Nenghabi, Environmental Sustainability Coordinator Lauren Belle, Sustainability Specialist

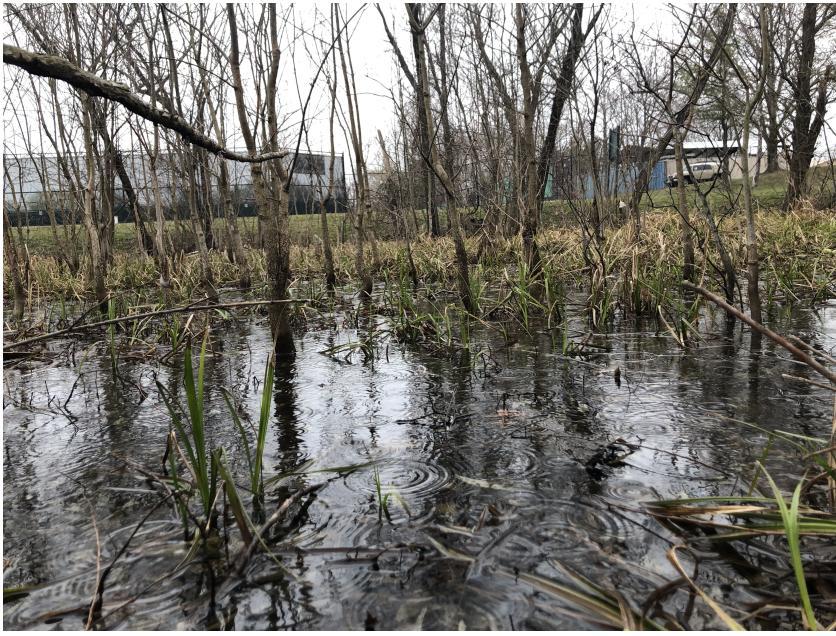
Image 3 shows the wet pond where the "treatment train" begins, with a filter, built to handle a 10-year storm. We observed that the *Juncus* (rush grass) is bright green, a good indicator of a wet area, as they absorb a lot of water, making them a good plant for SWM facilities. We did not observe many invasive species, primarily *Phragmites* (common reed), *Morus* (mulberry tree), and *Typha* (cattails). While cattails are native, they grow fast and can easily become invasive. The vegetation is not actively maintained because the staff wants it to mimic a natural wetland, but they seasonally remove litter and mow the grass.

Image 3: Wet pond, College Park Airport

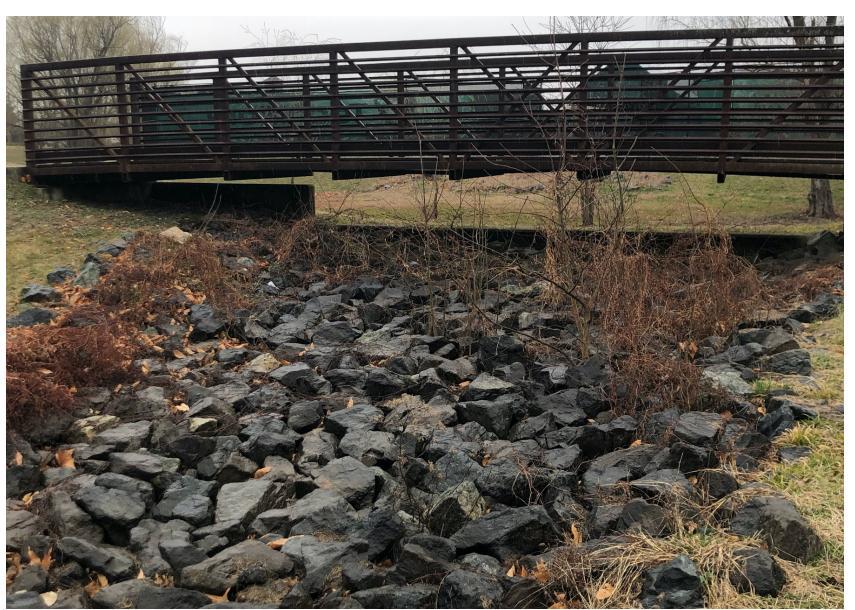
Image 4: Secondary catchment, College Park Airport

The secondary catchment (Image 4) is riprap, which was installed to slow water flow and absorb overflow when the wetland is saturated during a 50-year storm. There is a high-water table in the area, making it hard to filter additional water. This structure has received minimal maintenance, such as removing litter and invasive species, and is not on a maintenance schedule.

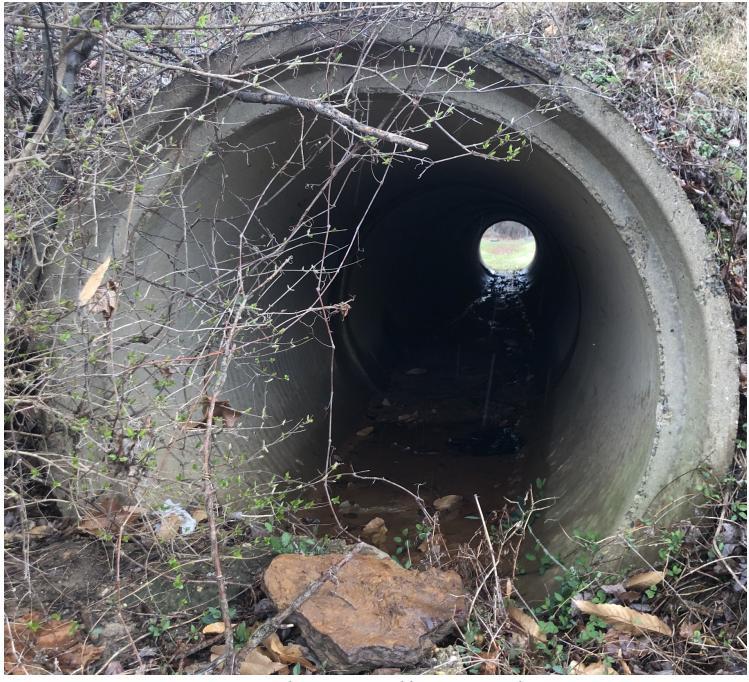
Image 5: Culvert, College Park Airport

The culvert at the Airport (Image 5) is the last step in the "treatment train." It has received minimal maintenance, such as removing litter, excess and invasive vegetation, and is not on a maintenance schedule. Some nearby *Salix babylonica*, (weeping willows) are excellent for absorbing water but are a menace to sewers, pipelines, and culverts.

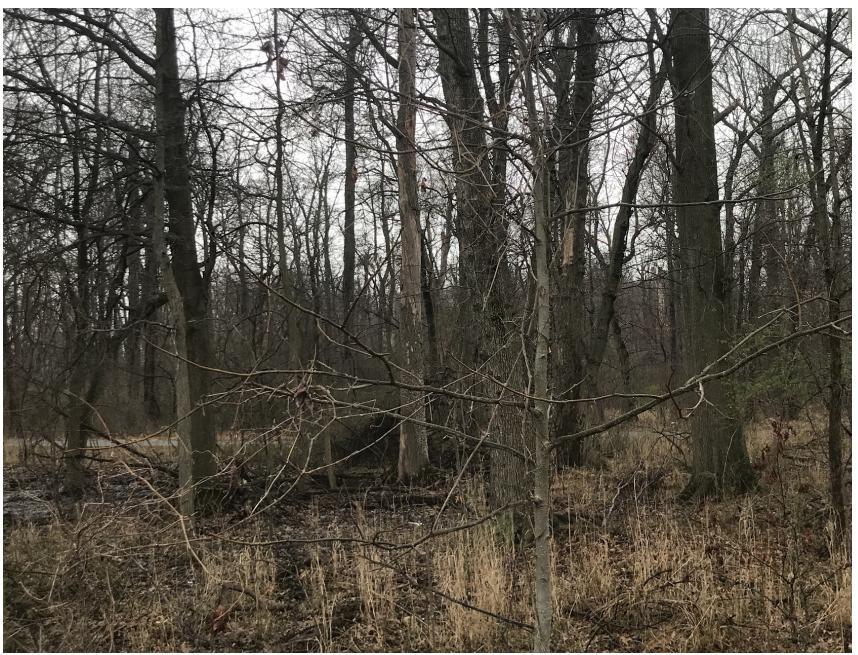
Image 6: Wetland, College Park Community Center

The forested wetland at the College Park Community Center (Image 6) was built in 2019 behind a riprap that was completed the day we visited. A geotextile membrane under the riprap prevents the rocks from sinking down. The wetland presented some invasive species, including *Rosa multiflora* (multiflora rose). There has been no maintenance, as the M-NCPPC staff want the area to mimic a natural wetland. There were, however, limits to the extent that trees could be disturbed to maintain a specific amount of tree coverage. Additionally, a concrete channel funnels runoff into the riprap and wetland from the large parking lot surrounding the Community Center.

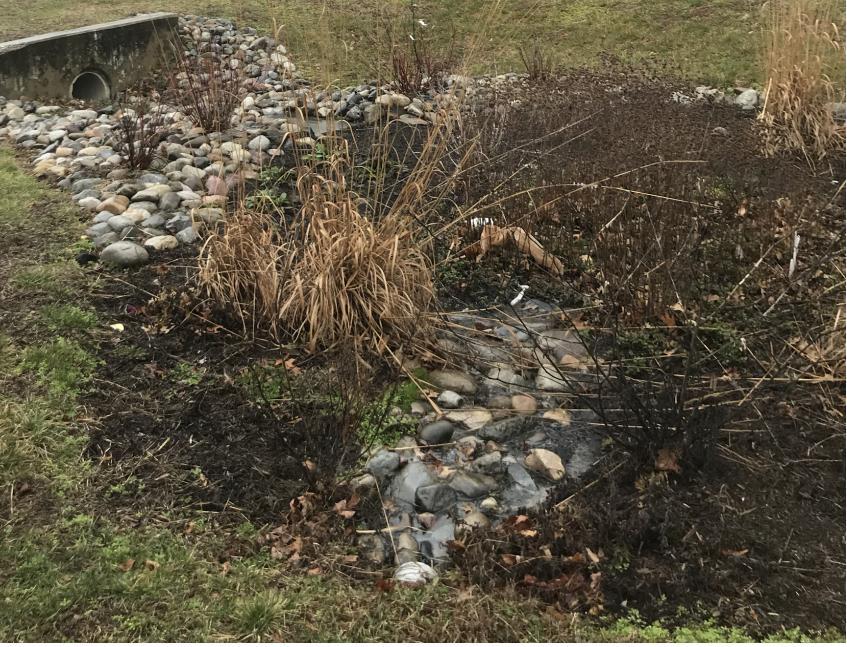
Image 7: Rain garden, College Park Community Center

The Community Center's new rain garden is relatively new (Image 7), installed in 2019. Itwas constructed to absorb 4,000 gallons of stormwater. There is a riverstone bed, not a riprap, which serves the same purpose of slowing down the water flow's speed into the SWM. Native plants include *Echinacea purpurea* (coneflower), *Asclepias tuberosa* (butterfly flower), *Acer* (maple tree), *Rudbeckia hirta* (black-eyed Susans), and *Cornus sericea* (redtwig dogwood). The site has been maintained, especially compared to the previous sites. The soil has been tilled with leaf barrels and mulched once a year, litter is removed, and invasive species are monitored and removed.

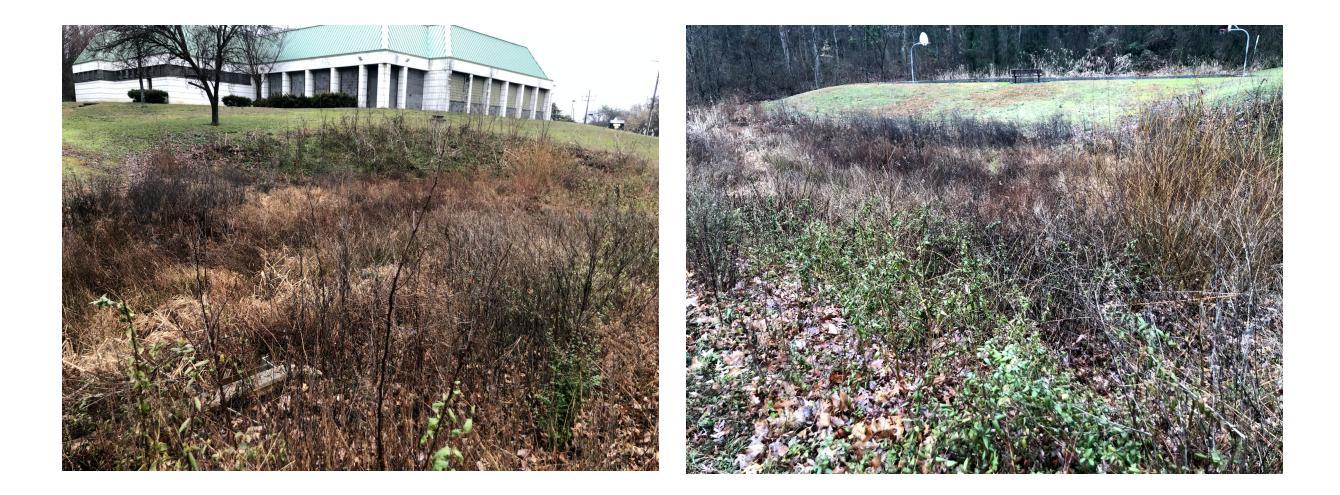
Images 8 and 9: Bladensburg Community Center Dry Pond Area

Images 8 and 9 show the dry pond area's two-tier stormwater drain. A large amount of trash was present in the dry pond, and it should be removed maintain function. Adding more waste bins in the area might decrease trash volume in the dry pond. The pond has a variety of vegetation, including the native *Juncus* grass (an indicator that the area receives water), *Typha* (cattails), thorny plants, and branches. The thorny plants should gradually be removed so that they don't hinder maintenance inspections. Very few trees were present in this area but can be found down the hill from the dry pond. The grass around the dry pond is well maintained but there are many invasive species in the area including *Rubus phoenicolasius* (wineberry), *Pyrus calleryana* (callery pear), *Phragmites australis* (a significant amount), and *Ligustrum* (privet). While these invasive species are present and haven't negatively impacted dry pond operations, they should be monitored and maintained to ensure that native species are not overrun.

an invasive. Some *Typha* should be removed to decrease its population density. During last year's maintenance inspection, *Typha* were targeted and removed. This practice should continue at the same frequency to keep the *Typha* populations under control.

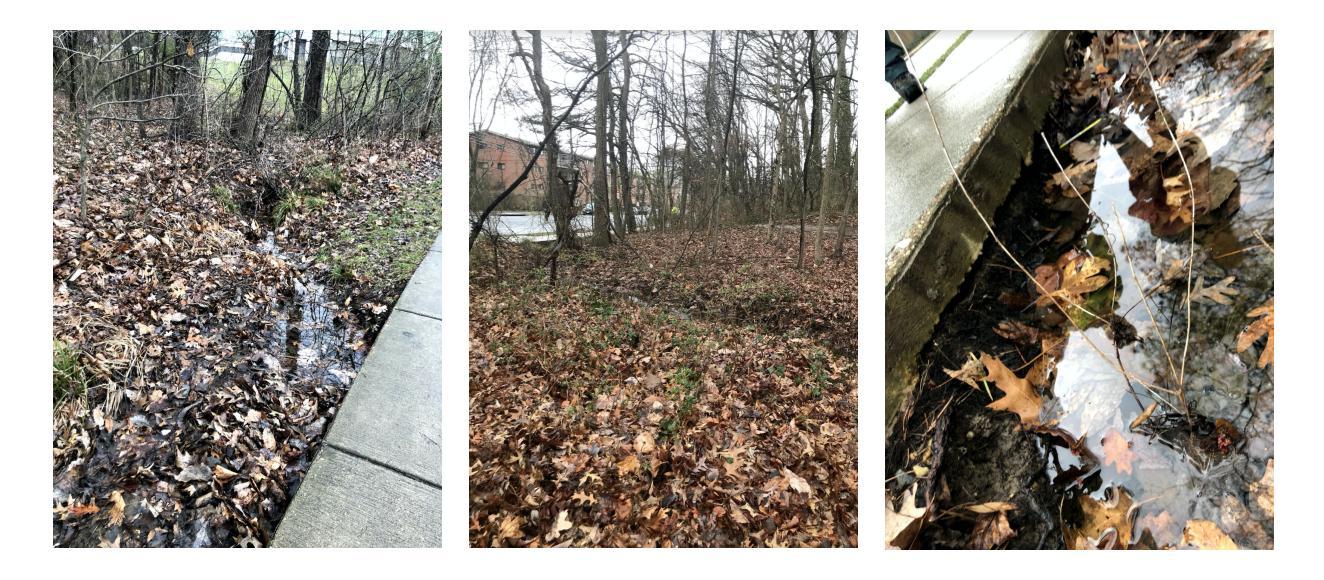
Images 10, 11, 12: Bladensburg Community Center stormwater drain and sidewalk erosion

Images 10, 11, and 12 depict the two-tiered stormwater drain; the first tier connects to a hill where the dry pond area is located. They are connected by a pipe that leads to a downhill area where the water can sit and gradually drain (Image 10). This area has many trees (Image 11), as well as a lot of leaf litter. Because it was raining during the site visit, the erosion beneath the sidewalk was visible (Image 12). The erosion beneath the sidewalk can potentially damage the sidewalk and pose a threat to public safety. Immediate maintenance is needed to divert water from the sidewalk area and repair the erosion. Water-absorbing plants in the second-tier area can help slow water flow outside of the pond, especially because the water flows downhill. Riprap could also be added outside of the pipe drainage area to help slow the flow of water there. The erosion under the sidewalk should be the highest priority for inspection to prevent further damage.

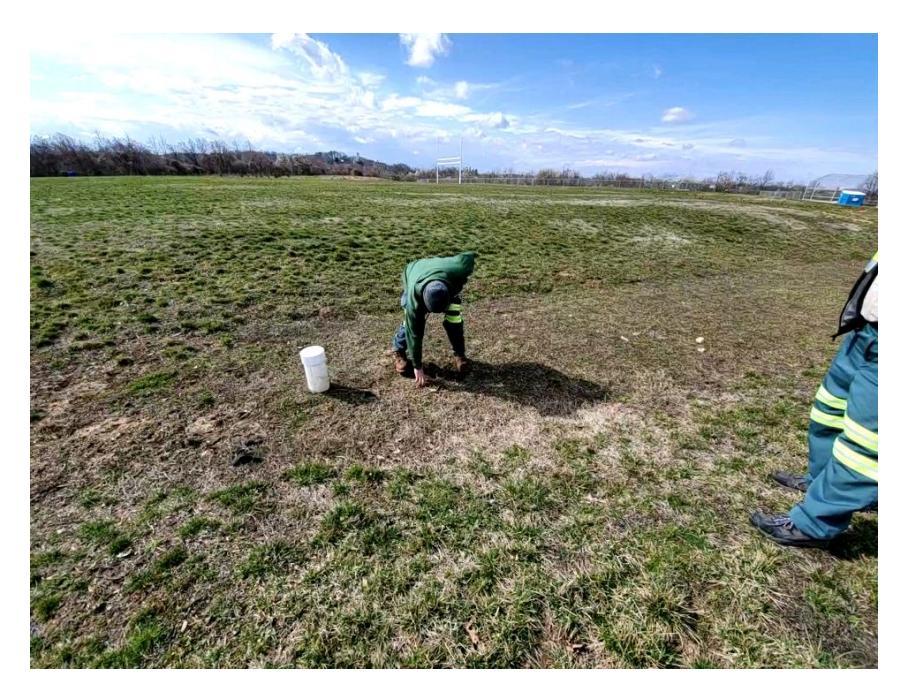
The Colmar Manor Park sites are several bioretention filter strips. One gulley was completely dry and lacked grass. Closer inspection, revealed a root-bound sample in the gulley, left by contractors who were hired to fill the strip with vegetation. The contractor had planted several different grasses, but they had all died due to improper care (Image 13).

Image 13: Bioretention filter strip, Colmar Manor Park

This SWM system's function could be optimized by creating assigning a task to plant appropriate grasses and vegetation. Once this task is complete, maintenance and watering should be a priority to ensure the system can function properly. Following initial maintenance, the structure should be regularly watered and debris and vegetative overgrowth removed.

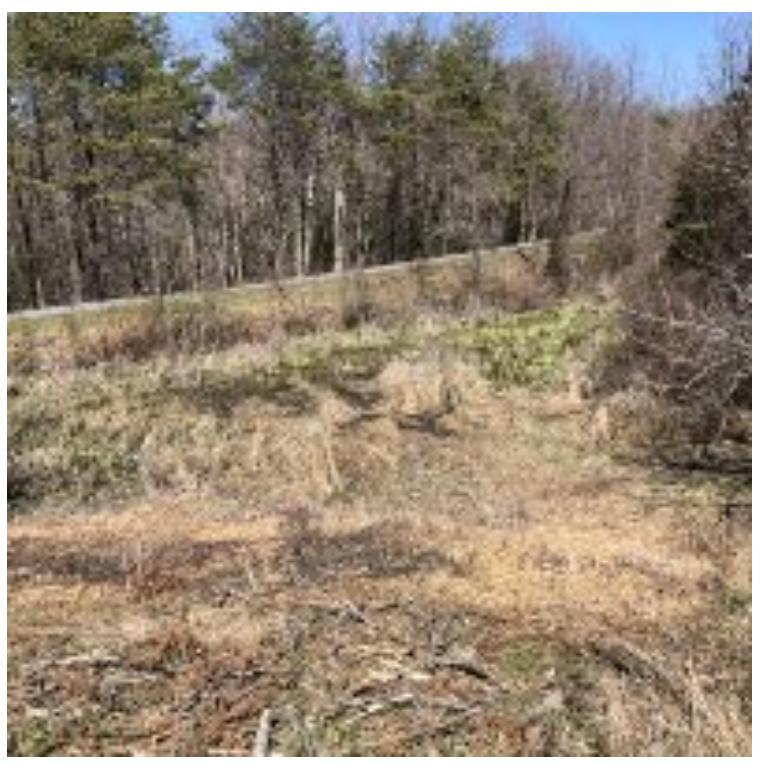
This SWM site was installed and is maintained by the Clean Water Partnership. The culvert ends in a marsh with numerous vegetation types in the culvert (Image 14), including several invasive species such as *Lonicera japonica* (Japanese honeysuckle), *Iris germanica* (iris), *Ranunculus ficaria* (lesser celandine), and *Pyrus calleryana* (Bradford pear trees). The culvert is not easily accessible due to a large amount of overgrowth (Image 15). Most noteworthy are the two deep eroded channels leading to the marsh.

Image 14: Marsh at bottom of culvert, Fairfield Center

The overgrowth should be cut back and invasive species removed. The area appears to be overrun by invasive plants that should be replaced with native species. The erosion should be addressed directly. Since the culvert is steep and very eroded, safety fencing should be considered.

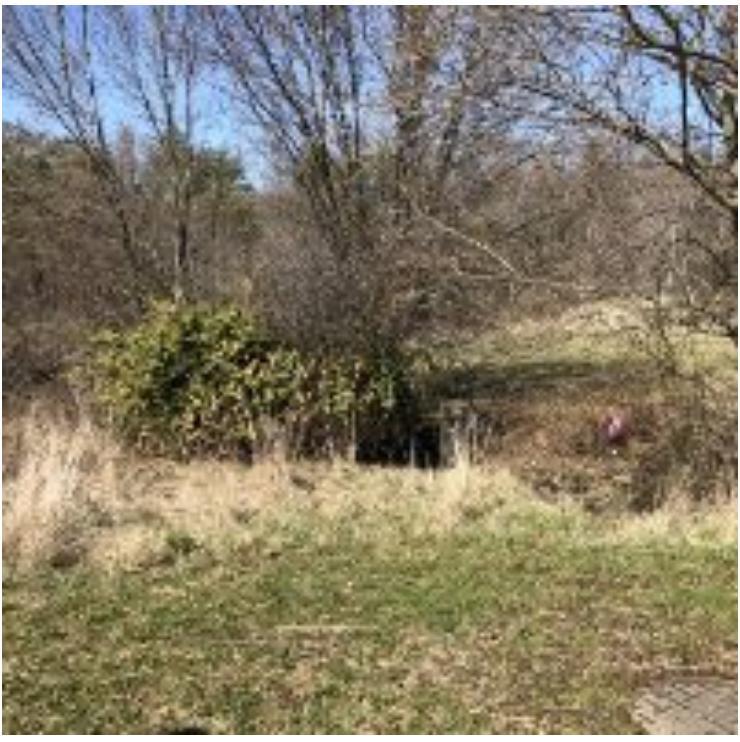
Image 15: Culvert with overgrowth, Fairfield Center

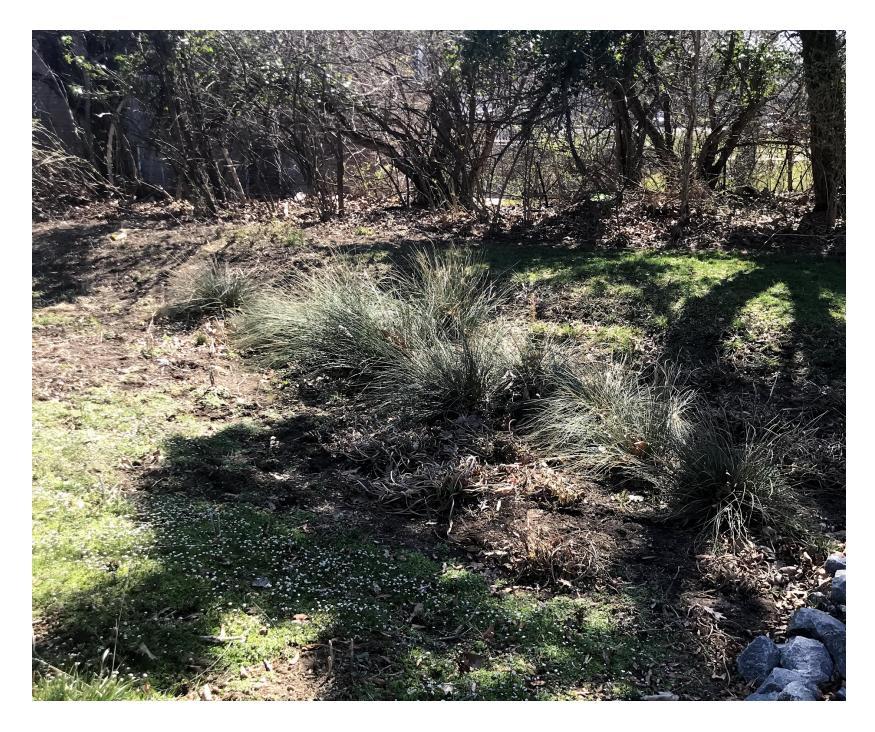
The bioretention ponds at Snow Hill Manor (Images 16 and 17) has received some maintenance, including removal of overgrown vegetation and invasive species. One of the ponds has a higher border, which reduces the downhill runoff, supporting the goal of treating and absorbing the stormwater on-site. There are minimal invasive plants, however, we documented *Glechoma hederacea* (ground ivy) and *Typha* (cattails). There is also tree canopy over the pond, which could produce leaf litter if not maintained.

Image 16: First bioretention pond, Snow Hill Manor

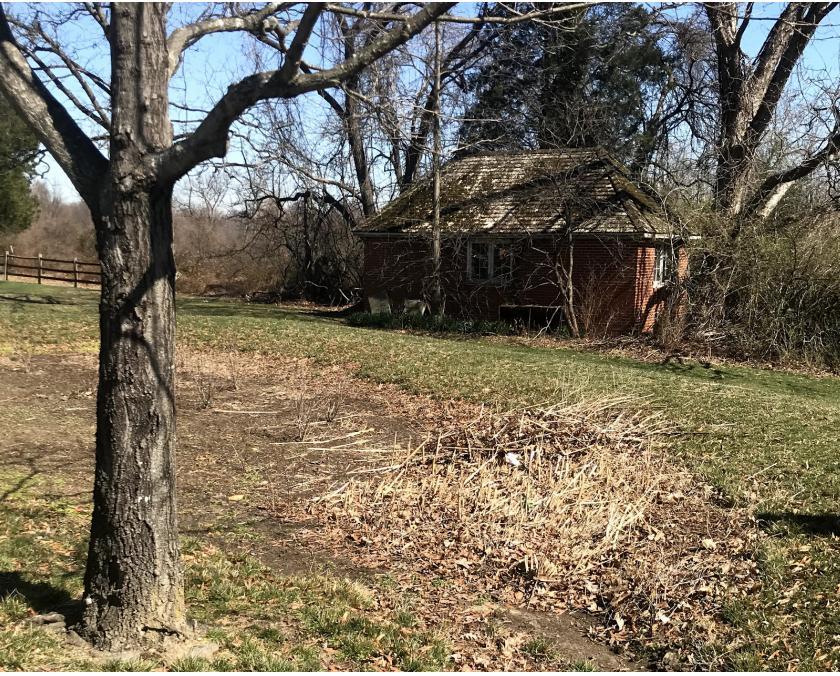
Image 17: Second bioretention pond, Snow Hill Manor

The second bioretention pond (Image 17) at Snow Hill Manor has no underground drain, and the current sand filter appears outdated. In 2018, a 100-year storm poured 51 inches of water in the area, which could not be absorbed and was left standing for days. DEP advised M-NCPPC staff to replace the sand filter, but testing determined that filtering speed, was two inches per hour, which was deemed adequate. The decision not to replace was made for financial reasons. The vegetation in the second pond is sparser and drier than the first pond and has significant erosion due to the presence of a parking lot.

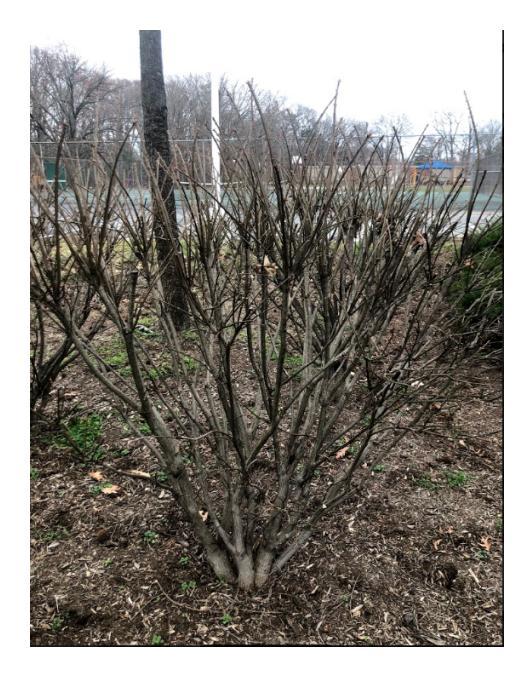
Image 18: Bioretention Area #1, Burning Bush Image 19: Bioretention Area #1, storm drain

vegetation, including the *Euonymus alatus* (Burning Bush), is invasive and should be removed (Image 18). We noted low-lying overflow drains in both structures, which can inhibit a bioretention area's ability to treat and infiltrate runoff (Image 19). Capping the lower holes of the overflow drain can address this issue. Furthermore, the edges of each bioretention area are intentionally carved out, which increases erosion, and should be discontinued. Overall, both bioretention areas were in decent condition with only minor problems (see Appendix 2 for completed checklists).

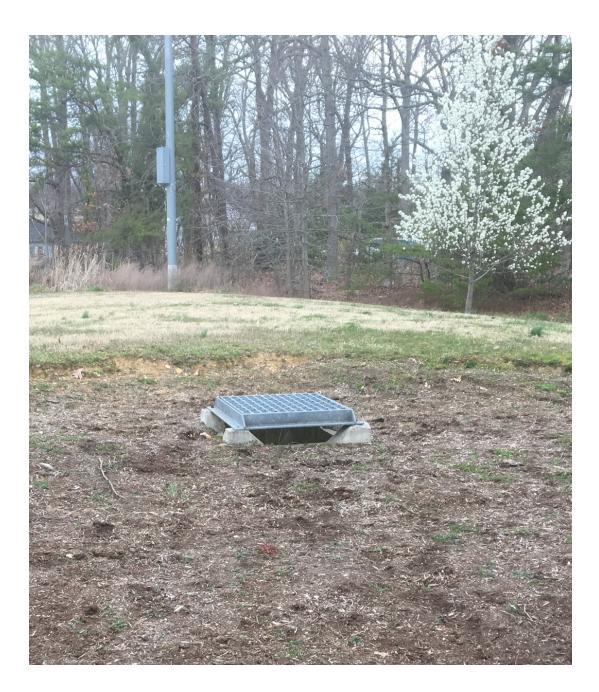
In both areas, we recorded little trash, no debris, or excess sediment. The mulch was in decent condition and there was no dead or overgrown vegetation; however, some planted

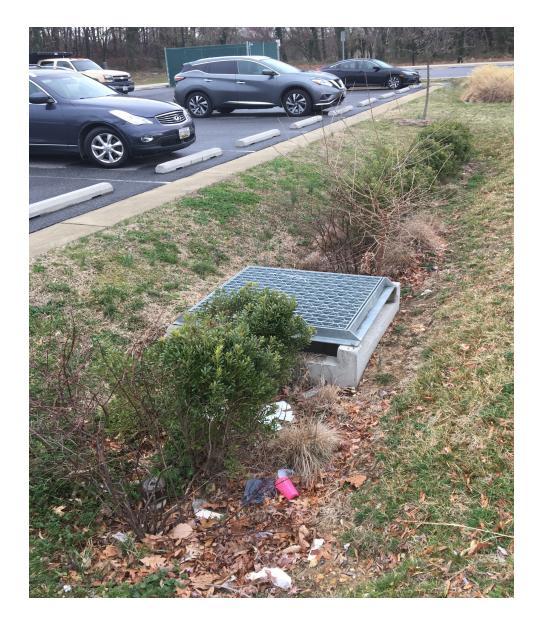
Image 20: Dry pond next to parking lot

At the William Beanes Community Center there are two dry ponds in the parking lot and one bioswale downhill of the parking lot. The dry ponds are in relatively good condition, but they haven't been inspected in the three years since the new Beanes Recreation Center was built. The dry ponds were built to withstand 10- or 20-year storms and are drainage areas for the parking lots. The bioswale is also relatively new, has not been inspected, and is designed to handle a 20-year storm. It is a second drainage area for the parking lots and bordering properties. There is also a tertiary catchment area adjacent to the bioswale that was planted with grass seed within the past year. After the grass takes root, the black tarp lining should be removed.

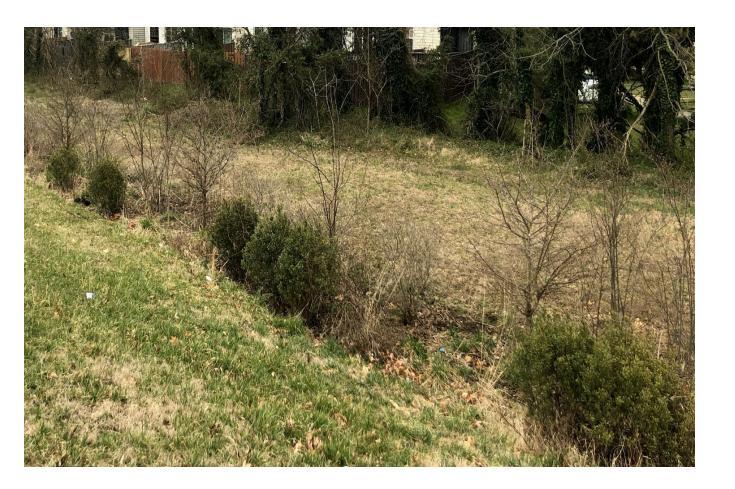
Image 21: Bioretention area at base of hill

will reduce maintenance costs and also help slow the water flow into the bioretention area. Overall the SWM structures at William Beanes Community Center need minor maintenance but are in good condition (see Appendix 2 for a completed checklist).

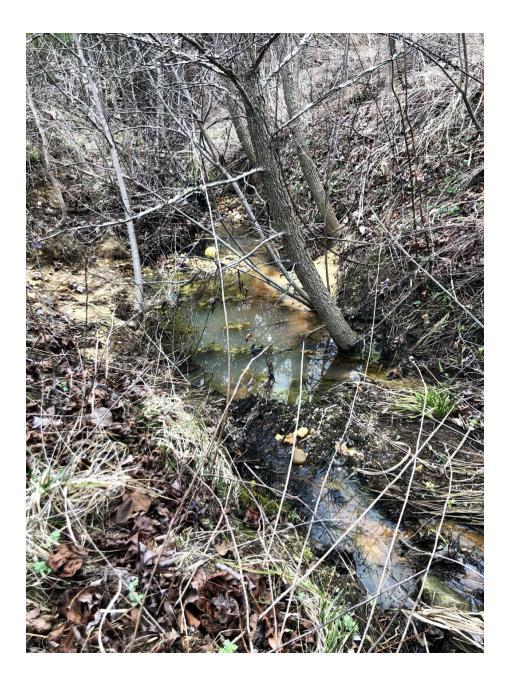
Image 24: Excessive streambank erosion

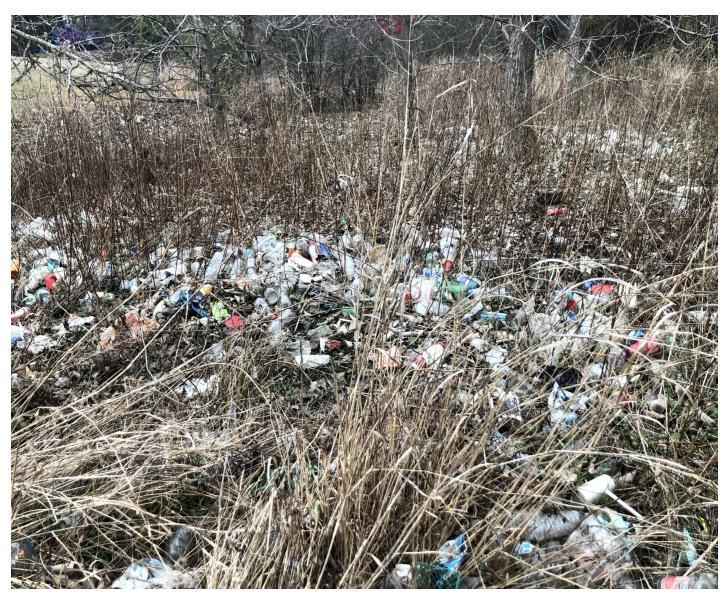
Image 25: Trash in the wet pond

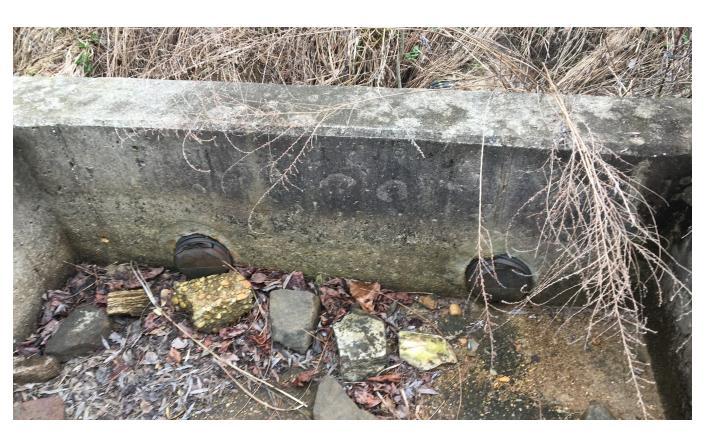
The most concerning issue in this wet pond was the damaged weir at the outlet. It was capped to prevent water flow from the outlet as designed. Subsequently, the water carved its own path by flowing around it and significantly eroding the banks beyond the outlet (Image 24). There is also erosion along the stream caused by the dysfunctional concrete weir. The weir should be closely inspected and repaired, including removing the cap (Image 26) to allow water flow. Dead vegetation should be removed and native vegetation planted along the stream banks to reduce soil erosion. Overall, this SWM structure needs serious attention, especially trash removal, weir repair, and vegetation remediation, to function properly and capture stormwater effectively (see Appendix 2 for a completed checklist).

Image 26: Capped and damaged weir
